Testing UAV-based Remote Sensing for Monitoring Well Pad Recovery

UAV Field Performance 2014 Summary Report

Prepared for the Alberta Biodiversity Monitoring Institute

University of Alberta Applied Conservation Ecology Lab

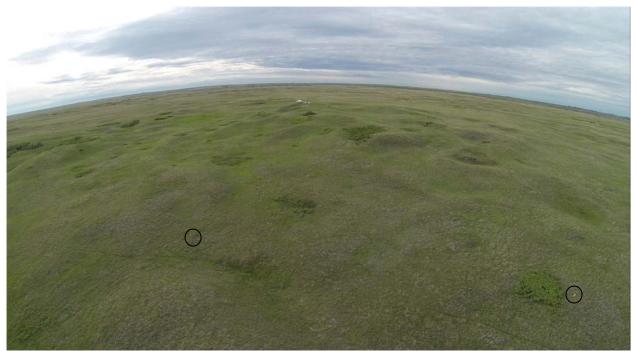
Figure 2. The RRI Mattheis Ranch landscape site consists of rolling hills of open dry mixedgrass vegetation. This aerial photograph was taken with a UAV hovering above plot centre; the base station can be seen in the distance and is located just outside the 16 ha trial survey plot. A red and a yellow GCP are visible in the foreground (circled).

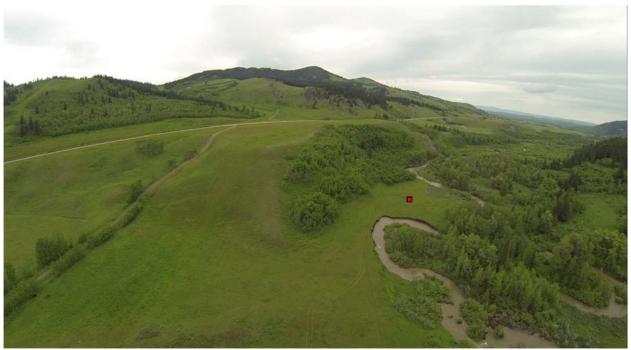
Figure 3. The Beaver Mines site in the Rocky Mountain foothills consists of a river valley floodplain and adjacent slope. The red mark indicates the approximate location of plot centre while the clearing and open slope to the left-middle of the picture is included in the plot.

Flight Trails were also conducted at a private property located just outside the town of Beaver Mines, Alberta in the Rocky Mountain Foothills. This site was meant to present more complex terrain, including large elevation gradients and forested areas (Fig. 3). The flight trail site was approximately 9 ha (300m x 300m) and consisted of a partially forested river valley slope ranging from 1315 m to 1345 m in elevation at coordinates N 49.4334° W 114.2222°. Flights were conducted between the dates of 18 to 20 June 2014.

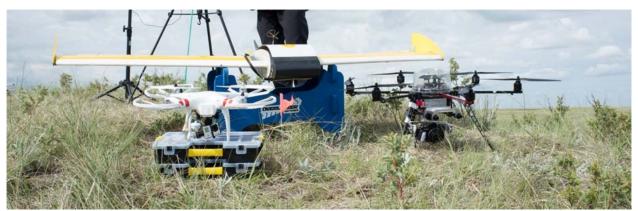
Figure 4. The three UAVs tested in Stage I. From left to right: The DJI Phantom quadcopter atop the toolkit, the fixed-wing Quest UAV on its stand, and the Mikrokopter hexacopter. The DJI Phantom's GoPro and Mikrokopter's Lumix G1 cameras are visible mounted on their gimbals.

Three UAVs were present at the trails, one large fixed-wing and two multi-rotor units (Table 1; Fig. 4). The UAV we flew was the DJI Phantom quadcopter (Fig. 5), an off-the-shelf ready-to-fly (RTF) consumer quadcopter representing the smallest, lightest, most economic end of the spectrum of equipment present. The specifications of the unit are highly limited, with no autonomous capability, an endurance of approximately seven minutes, and the most compact camera of the three units tested.

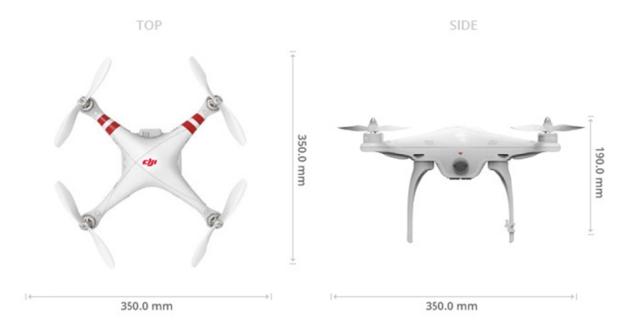
Figure 5. Top and side view of the DJI Phantom respectively in stock configuration without a gimbal or camera mounted.

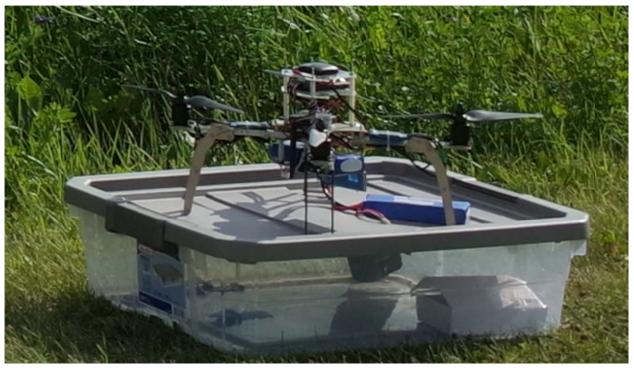
Figure 6. Photograph of prototype UAV in the field preparing to undergo a trial flight. The blue objects are the 5 Ah lithium-polymer batteries. The camera has been removed for arming.

The UA ACE Lab collaborated with the UA Department of Biological Sciences Fabrication Workshop in the engineering of components for the prototype UAV (Fig. 6). Components were designed in Adobe Illustrator and laser-cut or machined; G10 fibreglass composite formed the base and structure of the craft, with standard acrylic plastic used in the electronics and payload mounts. The flight computer used was the 3D Robotics APM 2.6, a proven and well-supported system used in many consumer and hobby UAVs. Stabilization and navigation were provided via on-board sensors including a gyroscope, accelerometer, tri-axis compass, barometric altimeter, and GPS receiver. Propulsion was provided by four T-Motor MS2216-11 900KV motors with 10/5 inch diameter/pitch carbon composite propellers; these were in turn powered by a 5000mah 30C 11.1v lithium-polymer battery back via a power distribution frame and four 30A DYS Electronic Speed Controllers.

Control and telemetry were provided via a 2.4ghz remote control receiver bound to a FrSky Taranis controller/transmitter, as well as a 3D Robotics 900mhz digital transceiver. The latter was paired with an identical transceiver at the ground station, connected via USB to a Windows 7 laptop running the open-source APM Planner v2.0 flight software. The software provides accurate realtime readouts of the UAV's status, heading and position on cached google maps imagery, as well as allows waypoint-based autopilot programming. Red and white LED strips were added to the front and rear of the UAV respectively to indicate forward facing direction from a distance.

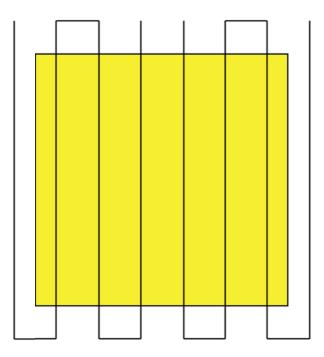
Figure 7. Mission flight pattern for the prototype UAV mounted with a Ricoh GR camera flying at 76 m altitude to produce 2 cm pixel size imagery of a 4 ha plot with 70% overlap.

Flight plans and mission parameters were developed with the objective of yielding a 2cm/pixel resolution of a 4 ha plot (200m x 200m) with >70% overlap. Flight trials with full payload and mission parameters were conducted at the University of Alberta South Campus, initially unsuccessfully, and the flight plans and parameters were refined iteratively. The final flight plan proven with repeated testing success consisted of two flights for each survey mission (Fig. 7) to allow significant safety room in battery lifespan in case of adverse an emergency. The flight pattern for each UAV mission was approximately 2.3 km long, flown at up to 25 km/h and captured aerial imagery at a rate of one per second.
